MAIN PUMP STATION 30" FORCE MAIN REPAIR PROJECT SUMMARY CITY OF PETERSBURG

RE: Main Pump station 30" force main repair summary

INTRODUCTION

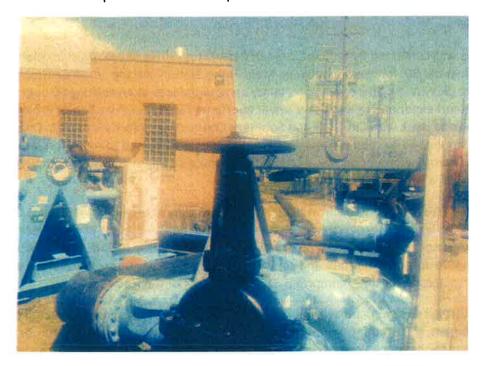
TEMPORARY BYPASS PUMPS AND FORCE MAIN TO SCWWTP

The contractor was directed to install bypass pumping with 8 MGD pumping capacity with a 16" temporary force main. The SCWWTP staff also indicated the discharge could enter the treatment plant headwork's in a fashion acceptable to SCWWTP operations staff.

The temporary pump operation and force main were installed and weather/treatment plant flow was monitored until conditions were favorable to begin the repair. Contractor was directed to demonstrate proper operation of the bypass before the pipe could be cut.

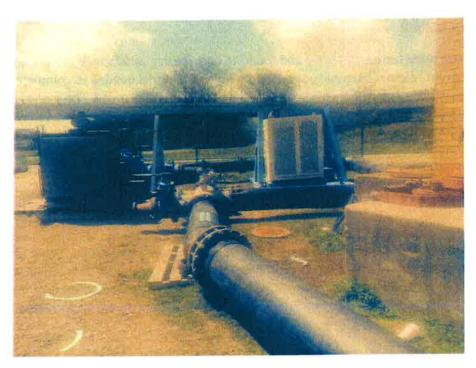
TEMPORARY BYPASS PUMPS WITH SUCTION MANIFOLD AND DISCHARGE FORCE MAIN

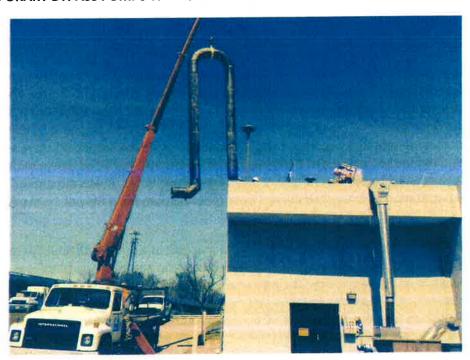
TEMPORAY FORCE MAIN DISCHARGE INSTALLATION AT SCWWTP HEADWORKS

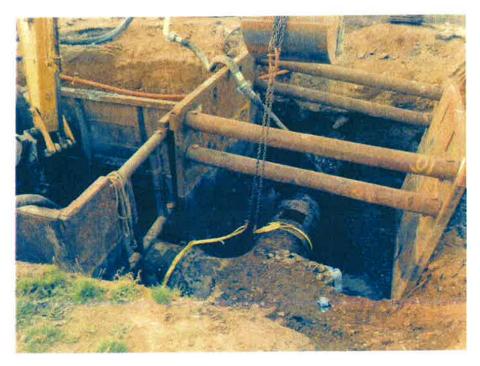
EXISTING 30" FORCE MAIN READY TO BE REMOVED

This leak was in a 1940's vintage cast iron pipe. The method used in providing watertight connections was to pour molten lead in a form which cooled between the bell and spigot of each piece of pipe. This was normal and customary for installing pressure pipe during this time period. Over time, the lead is exposed to pressure surges, expansion and contraction due to temperature changes and settlement of the pipe may also occur over time, compromising the integrity of the lead seal.

Colonial Heights staff were contacted and provisions to implement a pump and haul operation were scheduled without delay so repair could be completed. The pump and haul operation was in place by 3 pm and work resumed at the repair site. The pipe was cut and all liquid inside was pumped out. Than the pipe was removed, new pipe was installed and restraining mechanisms were install to allow Colonial Heights pump station to be placed back in service by 2 am on April 14. A concrete thrust block was needed to restrain the 30" from the thrust exerted on the pipe when main pump station was on line. This work was completed on April 14 and the line stop was removed from the 30" pipe. After the concrete achieved adequate compressive strength, the main pump station was placed back in service and bypass operation was discontinued.

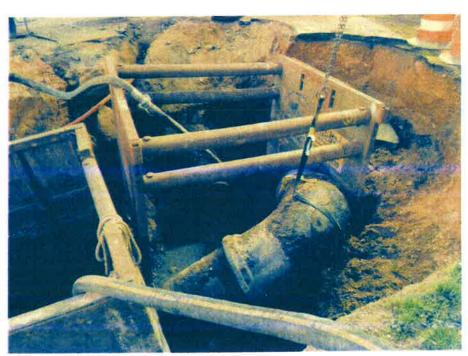
30" FORCE MAIN REMOVAL

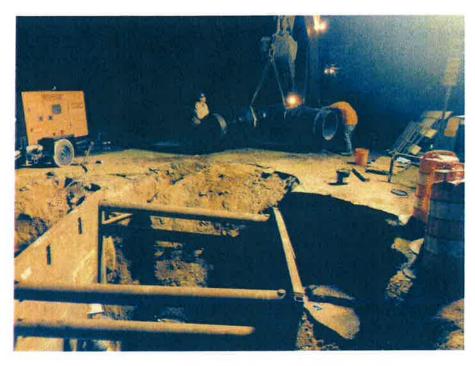
NEW 30" 90 DEGREE BEND AND PIPE READY FOR INSTALLATIO

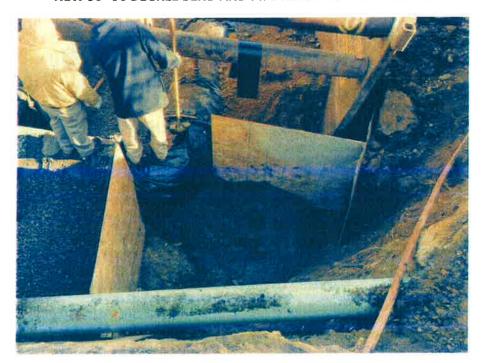
NEW 30" PIPE WITH CONCRETE THRUST BLOCK INSTALLATION 9 CY OF CONCRETE

Upon completion of the thrust block installation, the main pump station was placed back in service and the excavation remained open until the following day. There were no visible signs of leakage from the repair section or existing lead joint pipe connections directly adjacent to the new repair section.
